New Hampshire Volunteer Lake Assessment Program

2002 Interim Report for Little Round Pond Wakefield

NHDES
Water Division
Watershed Management Bureau
6 Hazen Drive
Concord, NH 03301

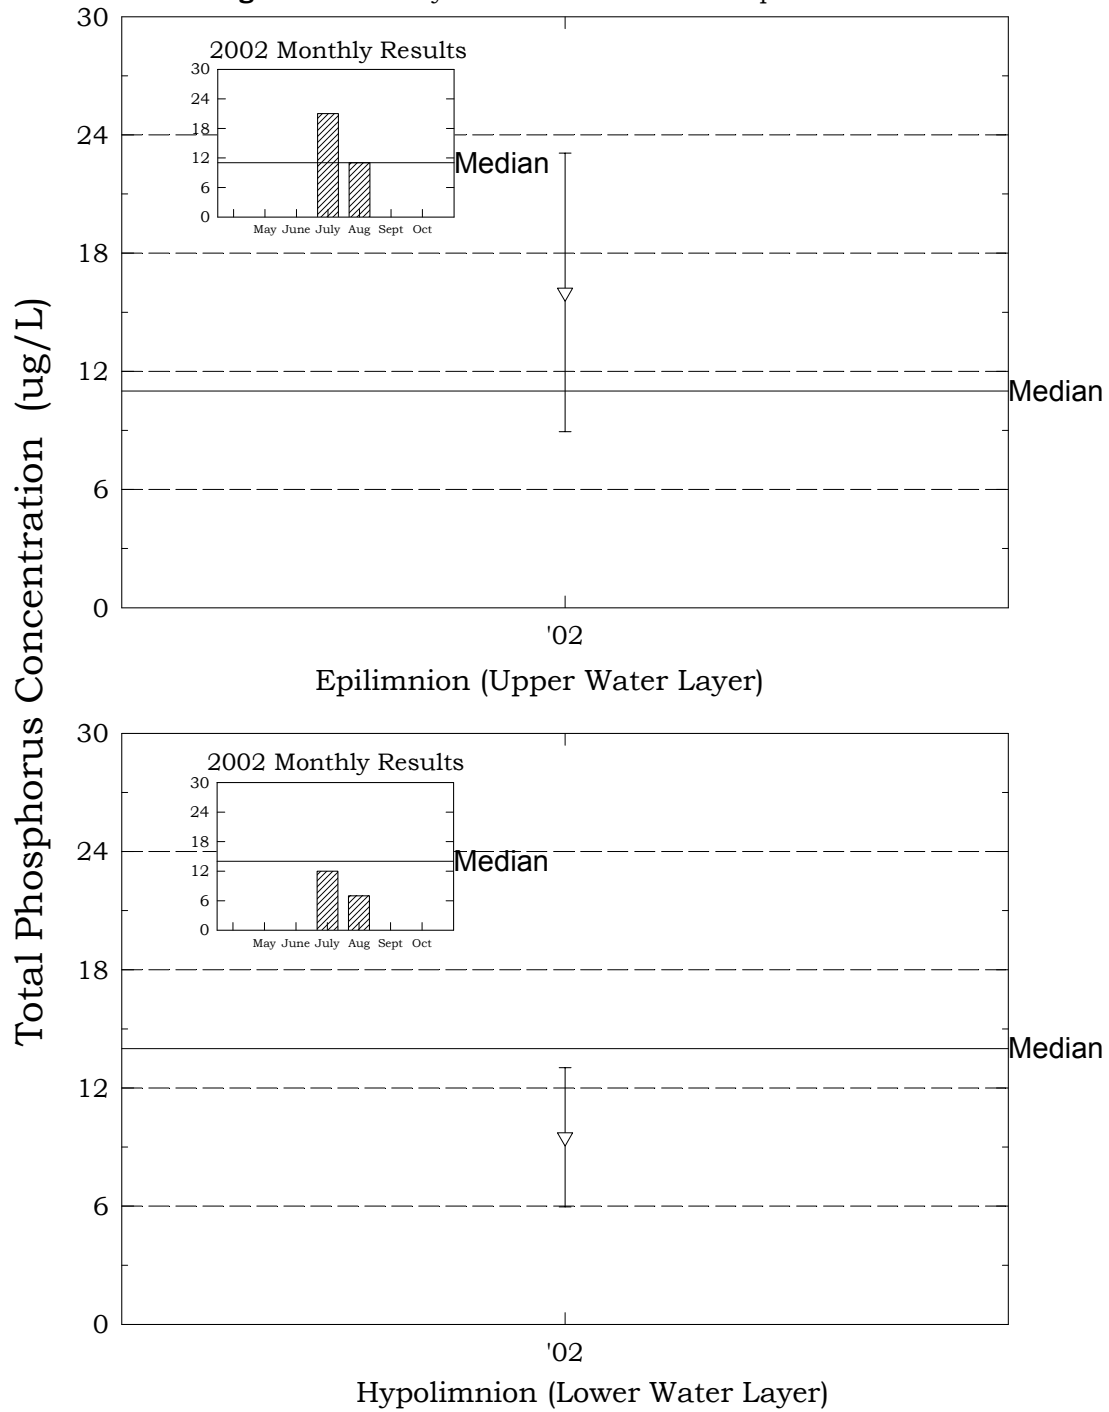
Figure 3. Monthly and Historical Total Phosphorus Data.

- **Figure 3 and Table 8:** The graphs in Figure 3 (Appendix A) show the amounts of phosphorus in the epilimnion (the upper layer) and the hypolimnion (the lower layer); the inset graphs show current year data. Table 8 (Appendix B) lists the annual maximum, minimum, and median concentration for each deep spot layer and each tributary since the lake/pond has joined the program.

The historical data for the epilimnion (upper layer) show that the 2002 total phosphorus mean is **greater than** the state median.

The historical data for the hypolimnion (lower layer) show that the 2002 total phosphorus mean is **less than** the state median.

One of the most important approaches to reducing phosphorus loading to a waterbody is to continually educate watershed residents about its sources and how excessive amounts can adversely impact the ecology and value of lakes and ponds. Phosphorus sources within a lake or pond's watershed typically include septic systems, animal waste, lawn fertilizer, road and construction erosion, and natural wetlands. If you would like to educate watershed residents about how they can help to reduce phosphorus loading into the lake/pond, please contact the VLAP Coordinator.
